Improved Materials For High-Temperature Black Liquor Gasification

James R. Keiser*, J. Peter Gorog**, Roberta A. Peascoe*,
James G. Hemrick*, and Camden R. Hubbard*

History Of Commercial Black Liquor Gasifier Constructed At Mill In New Bern, NC

When A Crack Was Found In The Gasifier Shell Several Sections Were Removed and Inspected

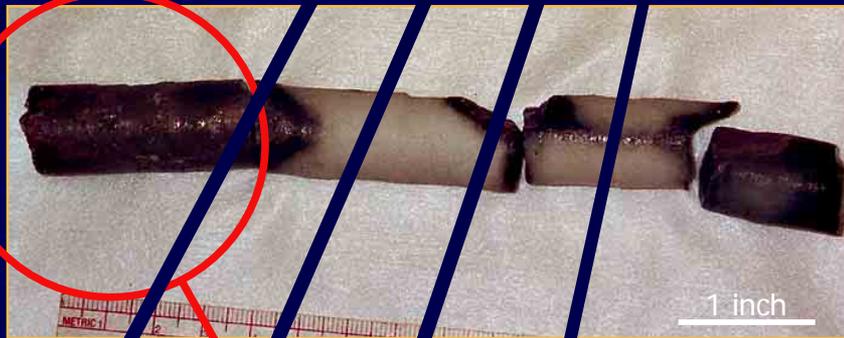
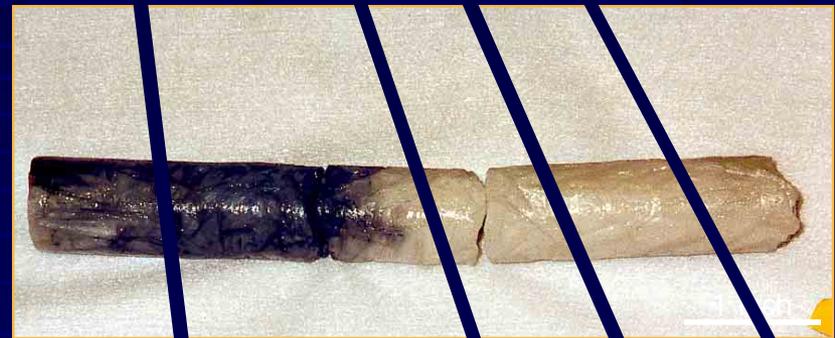
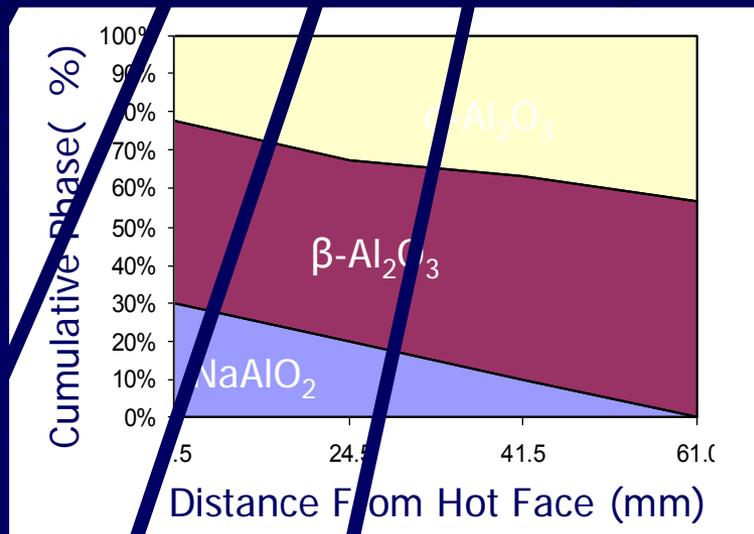
Working Lining: Jargal M

Backup Lining: Jargal H

- ❖ NaAlO₂ found on hot face
- ❖ Increased Na content found at back of the working lining and front of backup lining
- ❖ No NaAlO₂ detected in backup lining

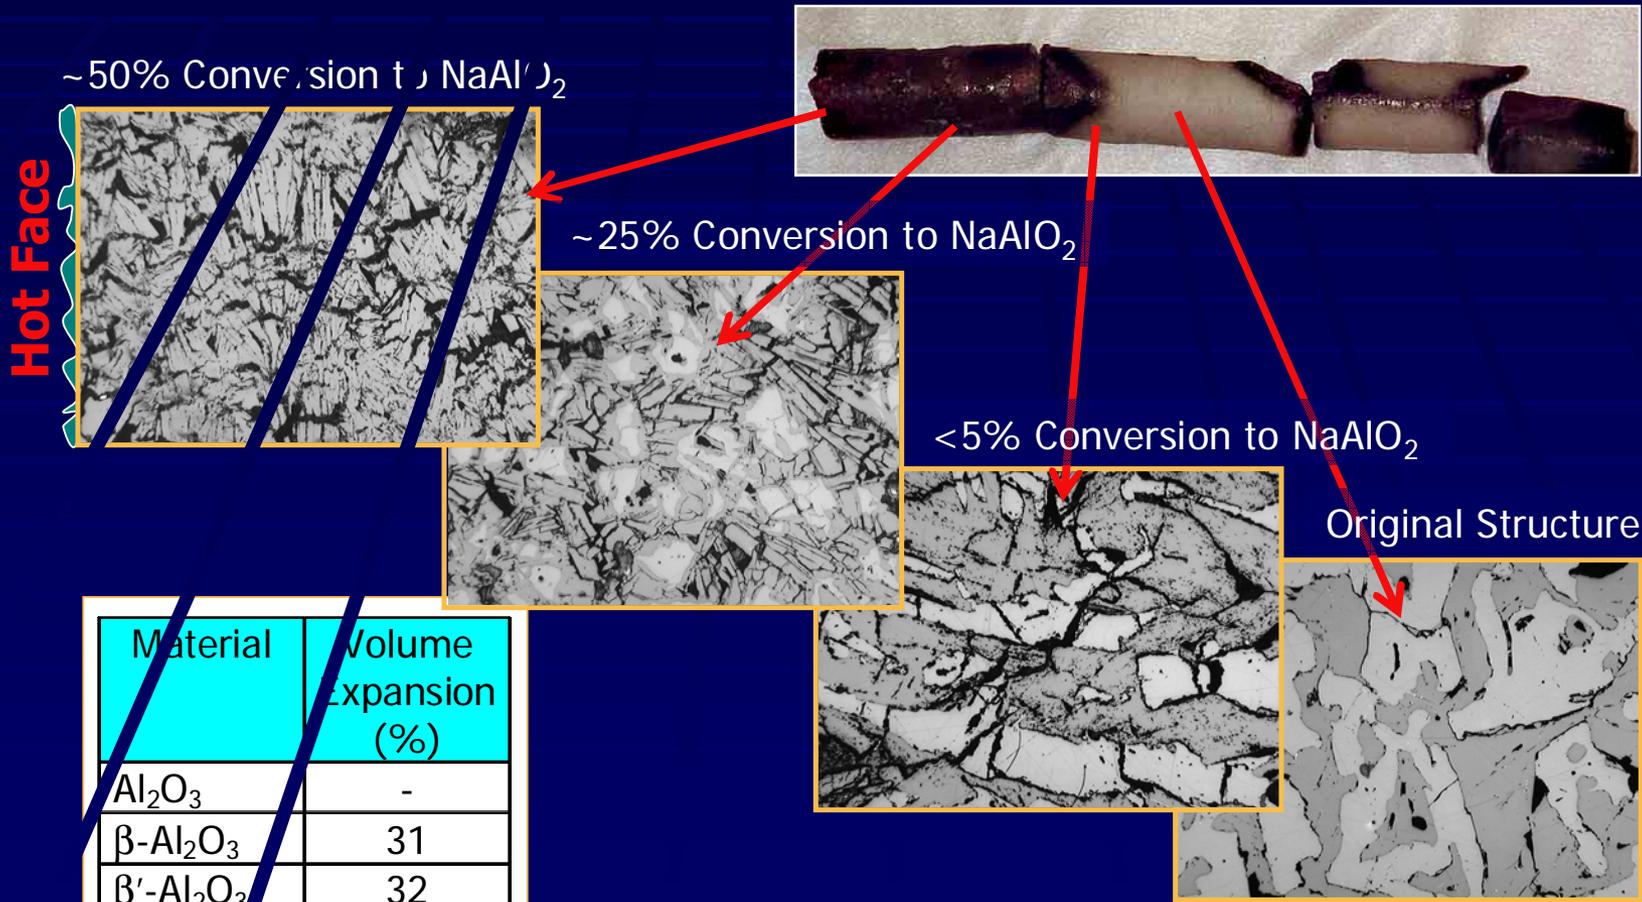
Observed Microstructural Changes Resulted From Reaction With Sodium

Material	Volume expansion (%)
Al_2O_3	-
$\beta\text{-Al}_2\text{O}_3$	31
$\beta'\text{-Al}_2\text{O}_3$	32
NaAlO_2	133

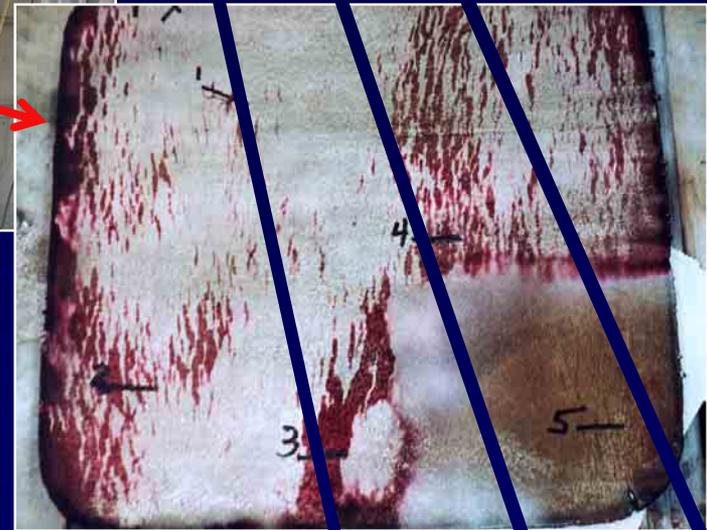
Dye penetrant tests showed many cracks in the vertical direction

- ❖ Mill water used during installation likely contained chlorides which contaminated materials adjacent to the shell
- ❖ Water condensed on the inside of the shell during start ups and shut downs and dissolved the chlorides
- ❖ Cycling of the unit concentrated the chlorides on the shell surface
- ❖ The chemical expansion of the refractory lining caused high tensile hoop stress in the shell
- ❖ The presence of tensile stress and aqueous solution of chlorides caused Stress Corrosion Cracking (SCC) in the 316L shell
- ❖ Tensile stress introduced during operation caused some of the cracks to grow through the shell
- ❖ Above mechanism repeatedly occurred until the pressure vessel failed

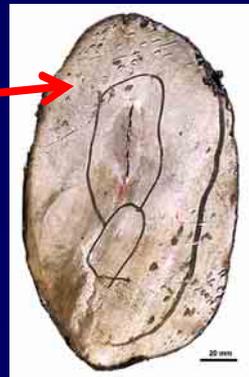
Through-wall crack on the shell was first indication seen by mill personnel

- ❖ Hemispherical Dome
- ❖ Carbon steel refractory containment which is not susceptible to Cl-SCC
- ❖ Crushable metal foam used between refractory and shell
- ❖ Fused cast alumina working lining over high alumina backup lining
- ❖ Expansion allowance for growth of refractory based on data collected after one year of operation

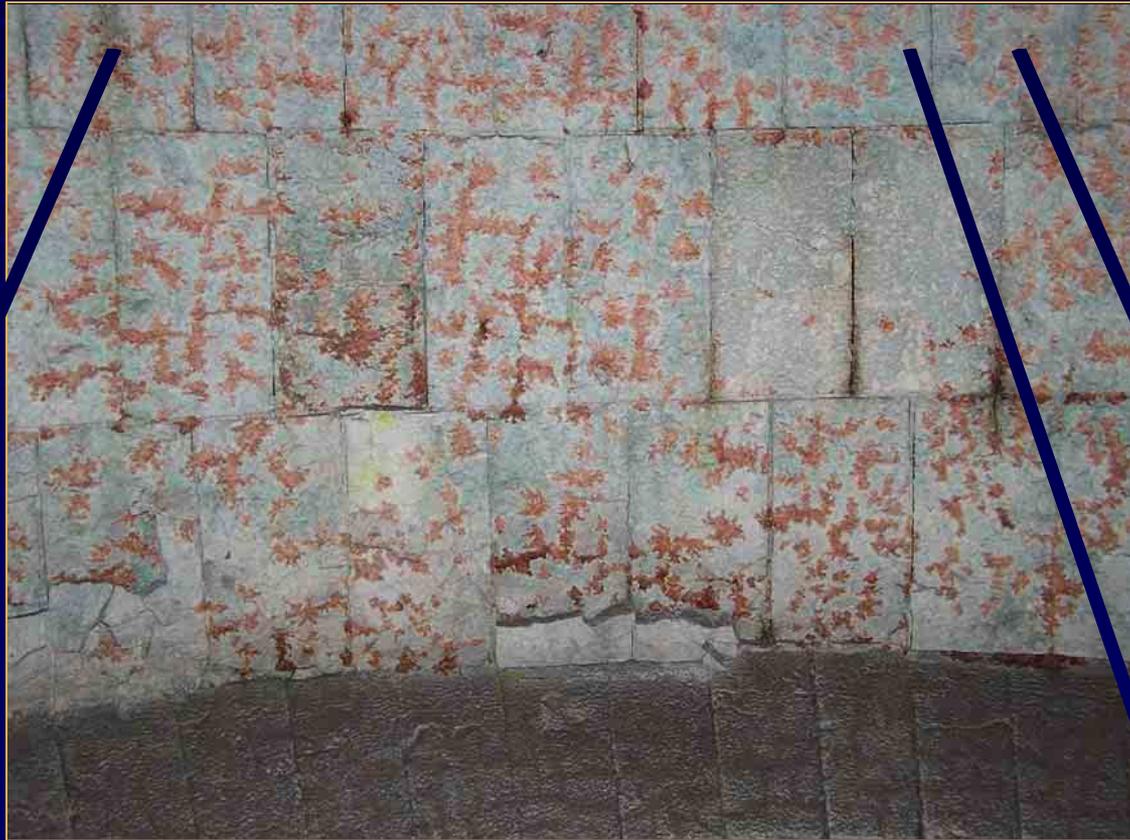
Refractory lining near bottom of barrel portion of gasifier vessel. Note red lines indicating apparent cracks on most blocks except for two in the second row (upper right).

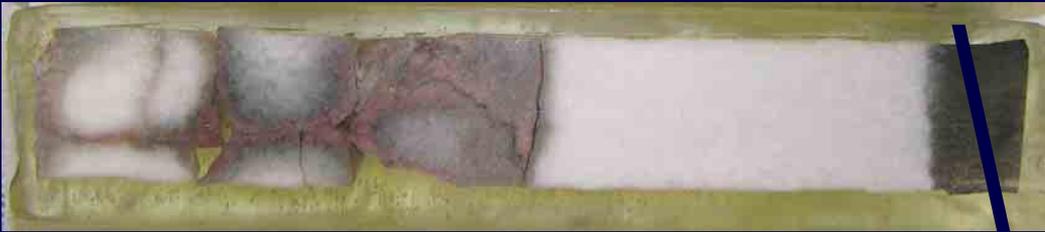
Fusion-cast alumina refractory

- ❖ The fusion-cast α/β -alumina showed less spalling than any refractory previously used for the vessel lining
- ❖ Cracking was evident through about the first half of the fusion-cast α/β -alumina bricks that were examined
- ❖ The fusion-cast magnesia-alumina spinel showed less cracking and penetration of sodium than the fusion-cast α/β -alumina
- ❖ The alternate fusion-cast α/β -alumina and the bonded magnesia-alumina bricks reacted more extensively

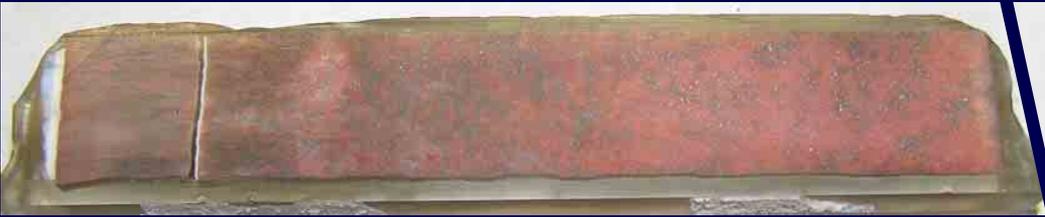
Fusion-cast magnesia-alumina refractory

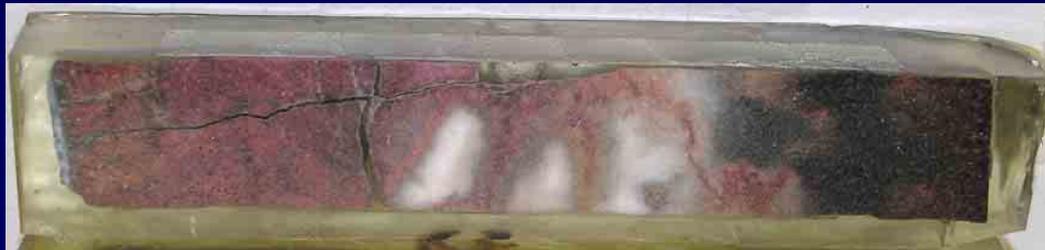
Alternative fusion cast alumina refractory

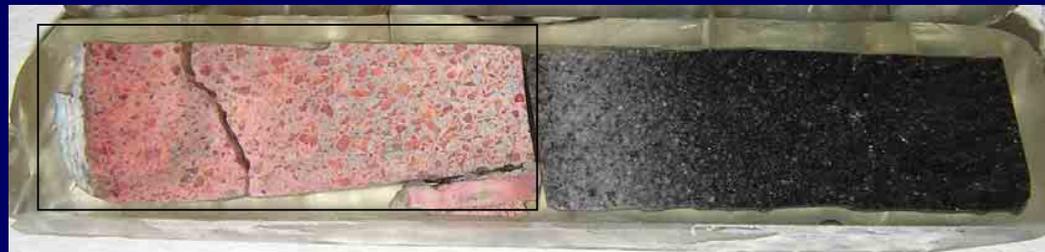
Bonded magnesia-alumina refractory (outlined at left)

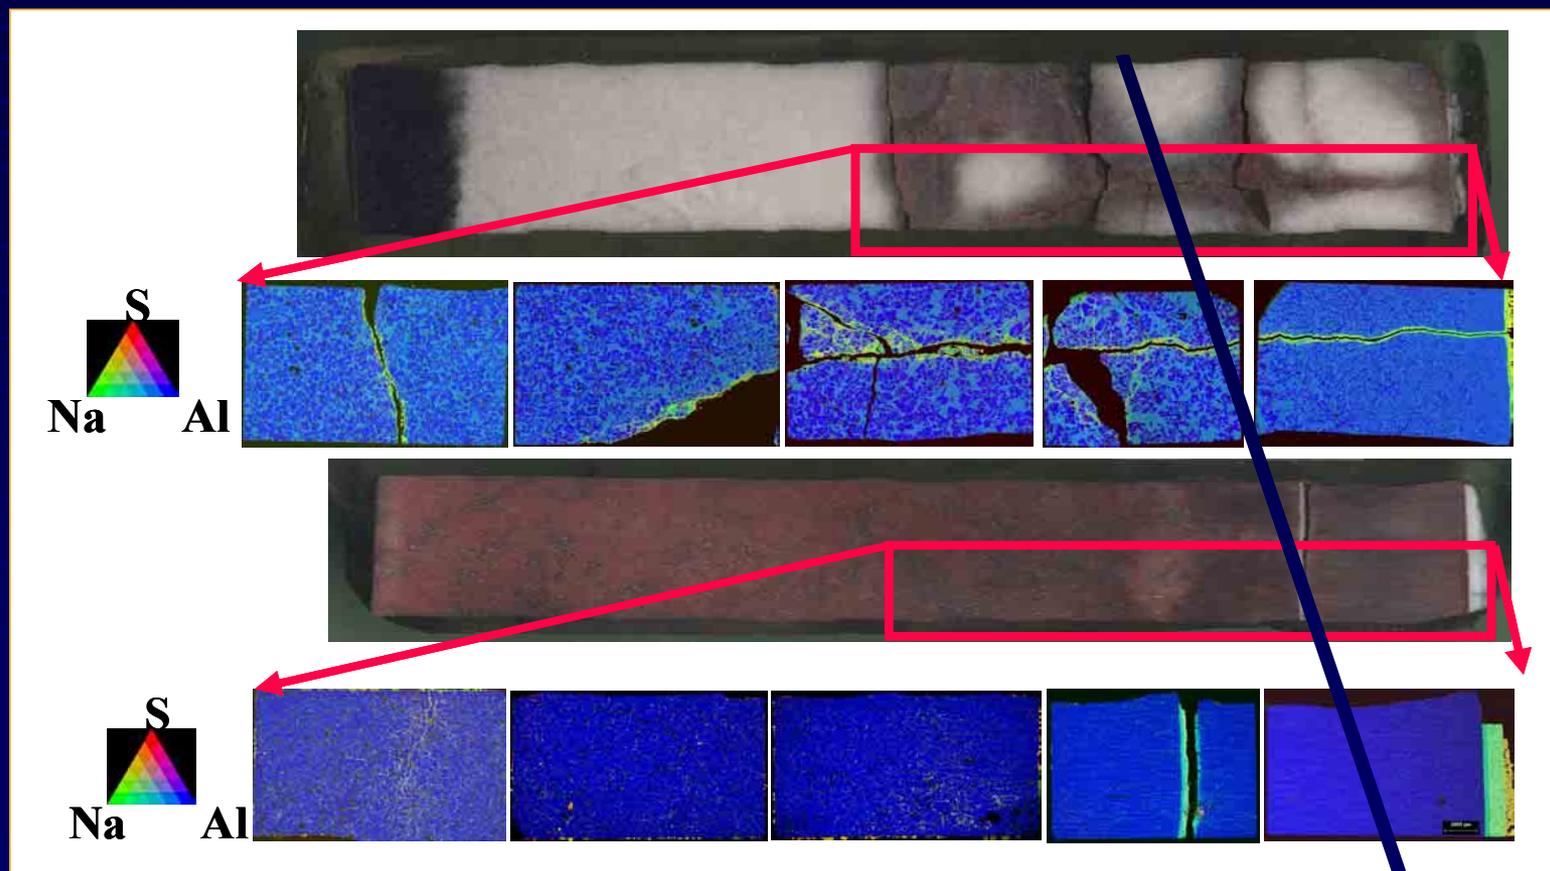
Overlaid elemental maps of sodium, sulfur and aluminum for the fusion $\alpha/3$ refractory (upper) and a fusion-cast magnesia-alumina spinel (lower).

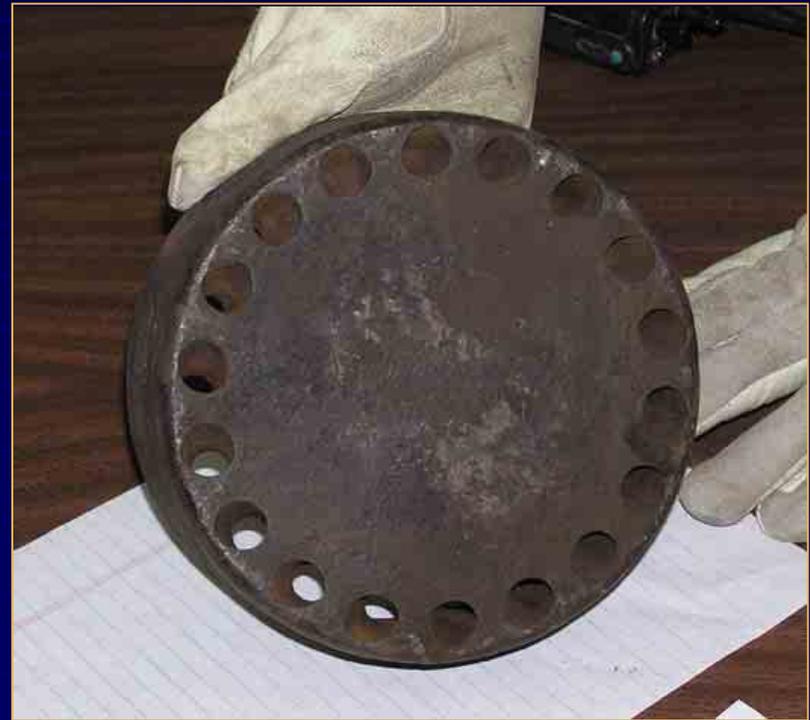
Delivery end of nozzle showing wastage

Inserts of various wear-resistant ceramic and metallic materials are being fabricated and will be tested in this system
