Improved Materials For High-Temperature Black Liquor Gasification

James R. Keiser*, J. Peter Gorog**, Roberta A. Peascoe*,
James G. Hemrick*, and Camden R. Hubbard*

History Of Commercial Black Liquor Gasifier Constructed At Mill In New Bern, NC

When A Crack Was Found In The Gasifier Shell Several Sections Were Removed and Inspected

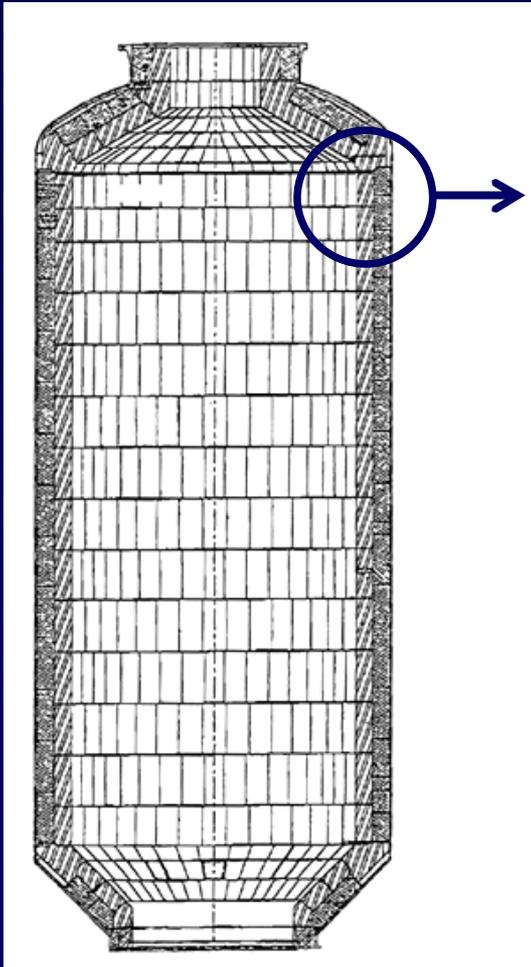
Original Fused Cast Alumina Lining Replaced The 60% Alumina Brick That Degraded Rapidly

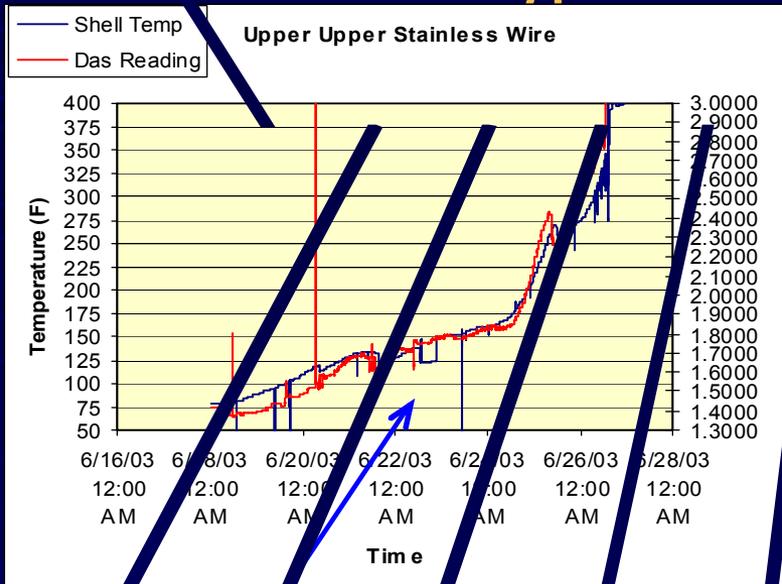
Typical LVDT Data Analysis

LVDT data tracker well with shell temperature at start up

Effect of shell loading can be seen

Day time - night time temperature variations

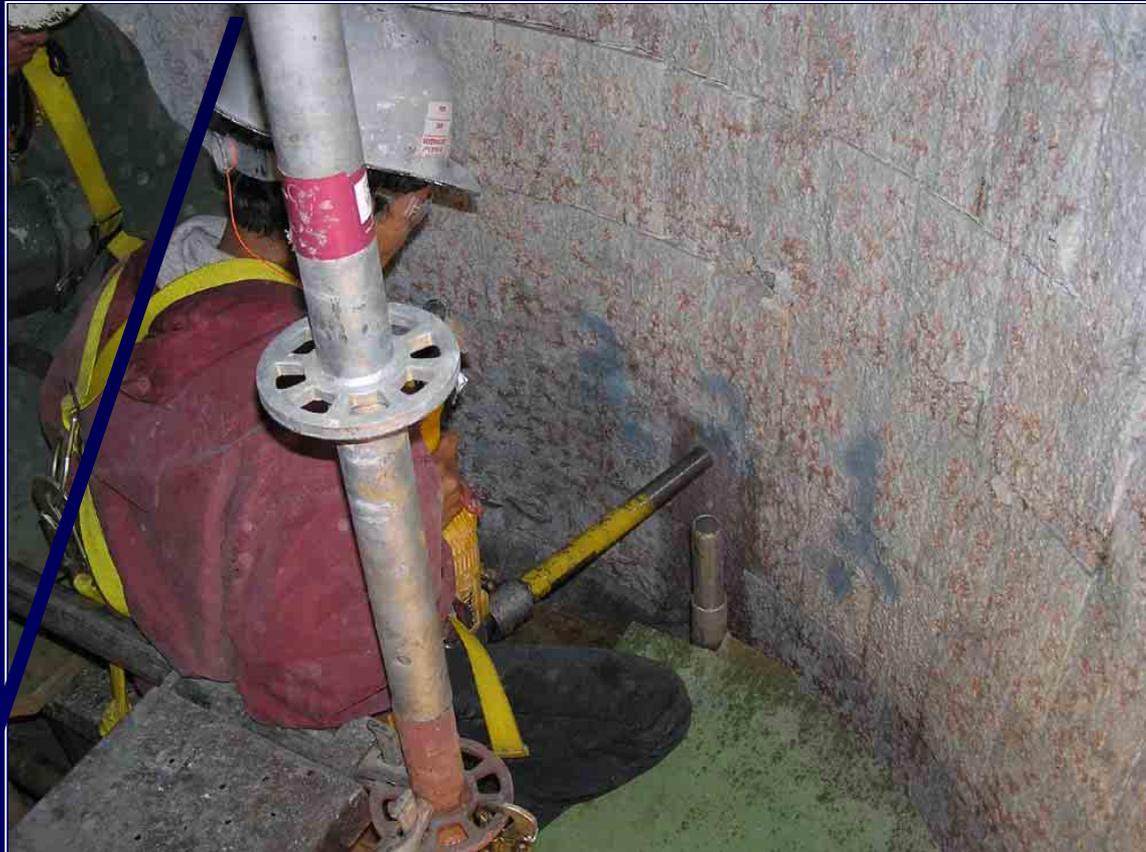
Core-Drilled Samples Were Collected From The Primary Refractory And Three Test Materials

Core drilling was done with kerosene instead of water as the lubricant/coolant to avoid dissolving water-soluble corrosion products.

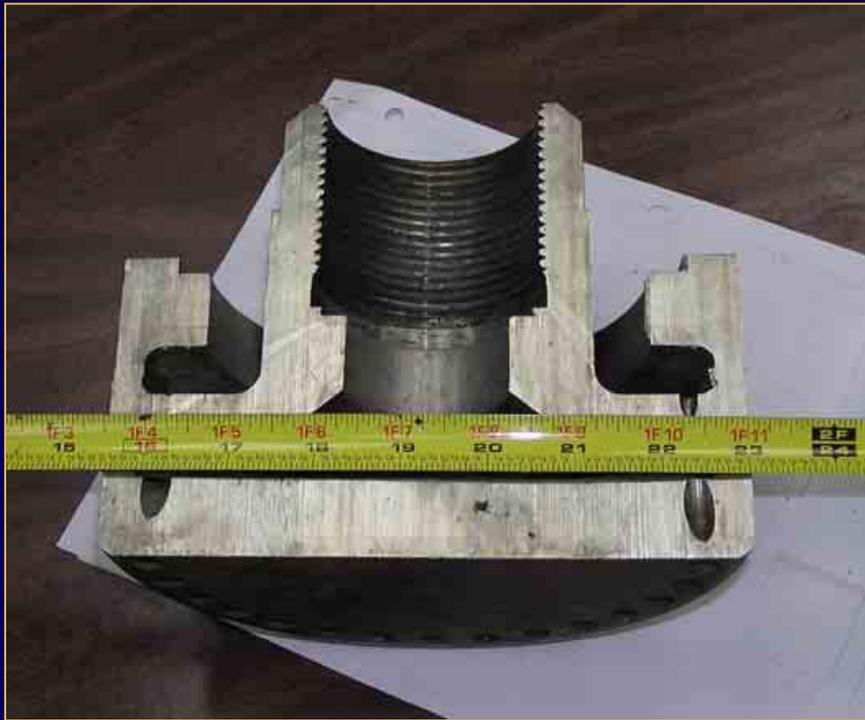
Current Black Liquor Injection Nozzle Mixes Steam And Liquor But Exit End Of Holes In Nozzle Suffer Significant Wastage

Cross section of black liquor nozzle

The New Nozzle Allows Insertion Of Wear-Resistant Test Materials
